SCOTTY'S LAKE DAM

MO 10271

**PHASE 1 INSPECTION REPORT
NATIONAL DAM SAFETY INSPECTION**

MARCH 1979

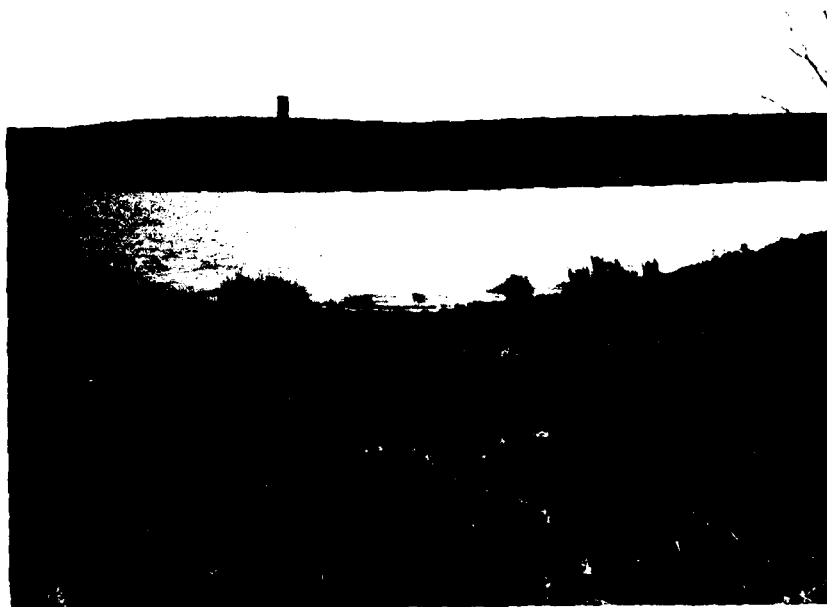
c. Appurtenant Structures. The inspection team observed the following items pertaining to appurtenant structures. An earthen channel spillway that was constructed near the left abutment appears in fair condition. The spillway is acting as a broad-crested weir. There is no side slope or channel protection in the spillway.

PHOTO 8: EMERGENCY SPILLWAY (LOOKING UPSTREAM)
